PERIODIC REVIEW

**Clyde Revord Motors
Facility Site ID#: 63754759**

**7900 Evergreen Way,
Everett, Washington**

June 2010

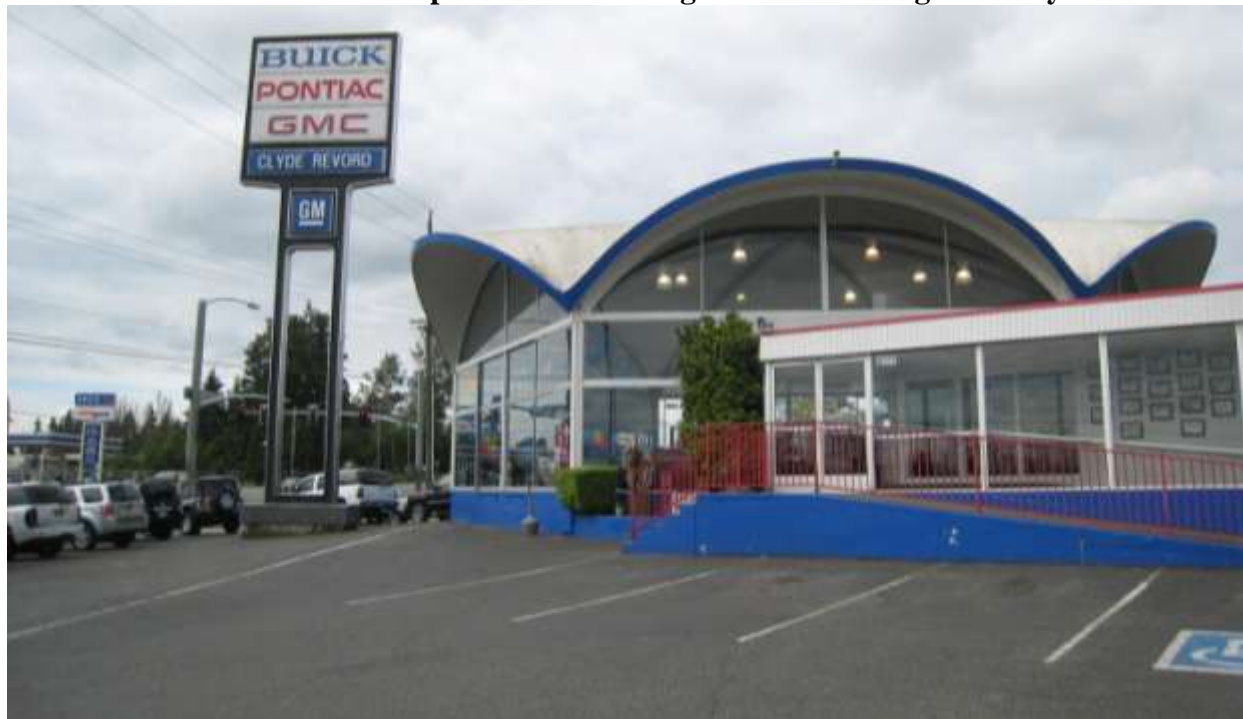
Photo 1: Front Showroom and part of North Wing - from the Evergreen Way side

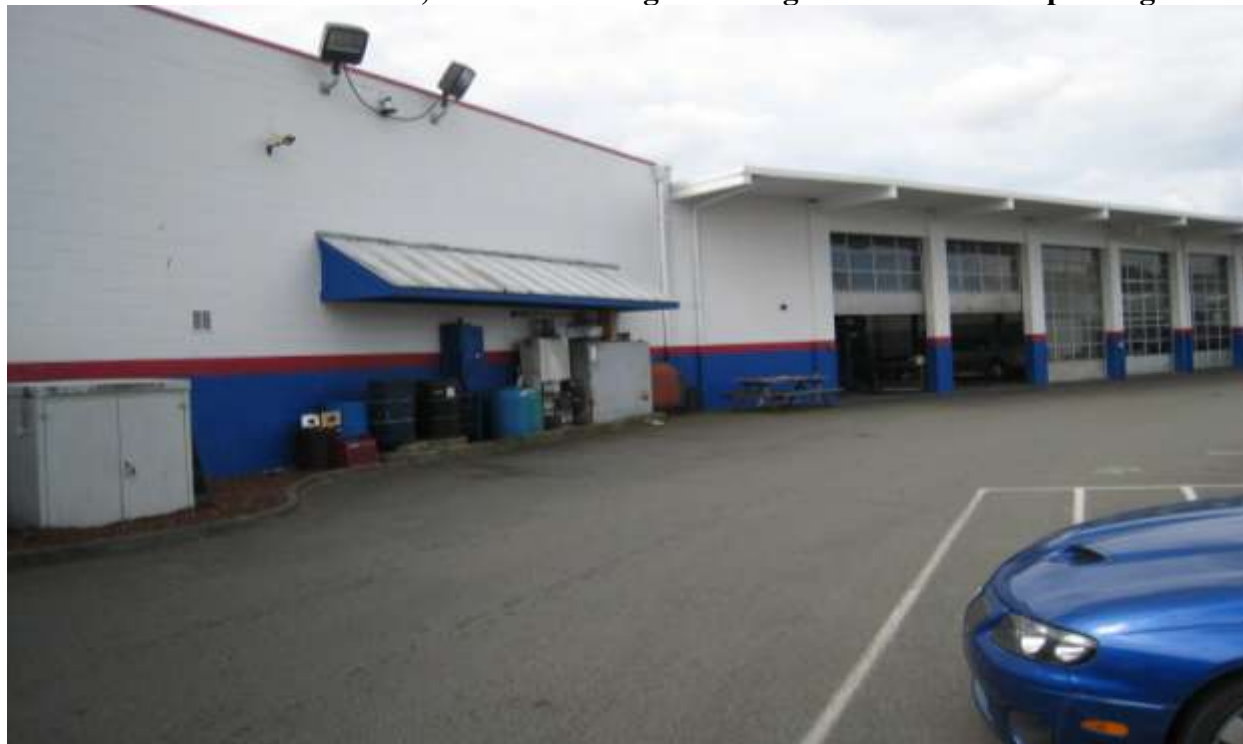
Photo 2: Area of UST removal, and South Wing on the right - from the rear parking lot

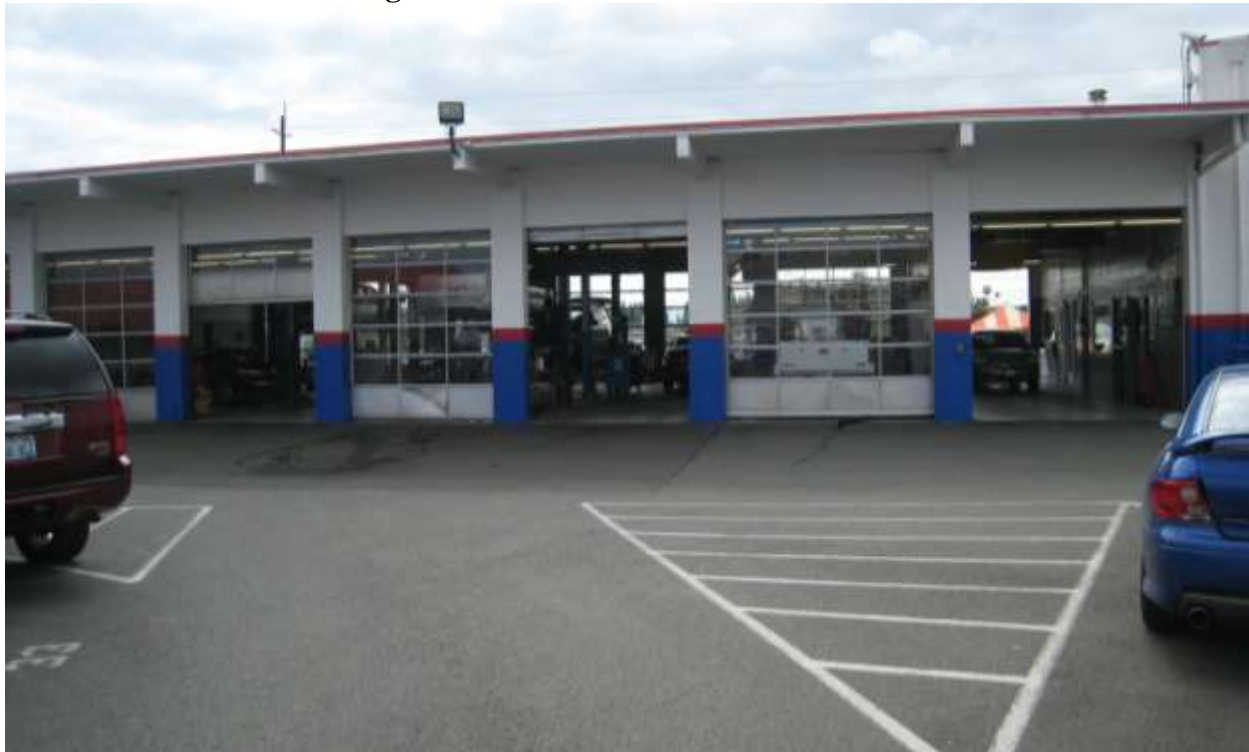
Photo 3: Rear of North Wing - from the west

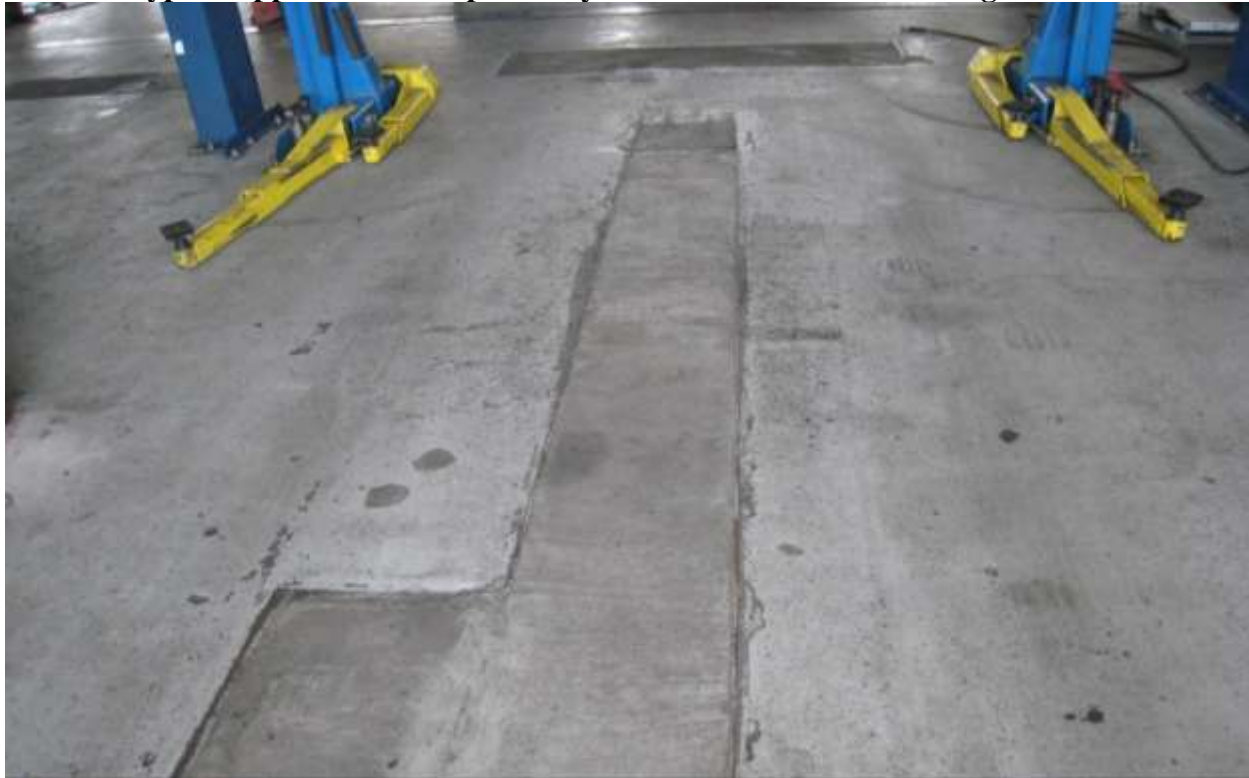
Based upon the Site visit conducted on June 30, 2010, the building garage floor and asphalt cover (remedy) at the Site continue to eliminate exposure to contaminated soils by ingestion and contact. The remedy appears in satisfactory condition and no repair, maintenance, or contingency actions have been required. The Site is still operating as a automobile dealership. A photo log is available as Appendix 6.5.

Photo 4: Typical appearance of repaired hydraulic lift area inside a wing
